# An Examination of Safety Reports Involving Electronic Flight Bags and Portable Electronic Devices

## **Final Report — June 2014**

DOT-VNTSC- FAA-14-12

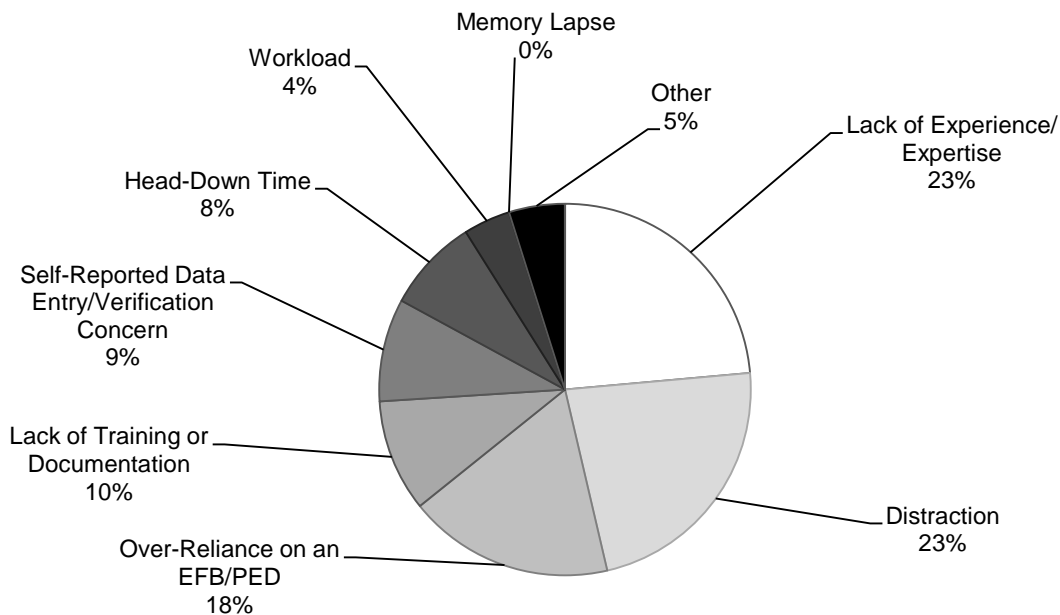
**Figure 7. Percent of Self-Reported Human Performance Concerns Reported.**

This category captures undesirable effects on human performance associated with the use of an EFB or PED being used as an EFB, as well as *self-reported human performance* concerns associated with entering data in the EFB/PED. Figure 7 shows the percent of *self-reported human performance* concerns reported overall. Table 7 shows concerns reported by Part 91, 121 and 135 pilots.

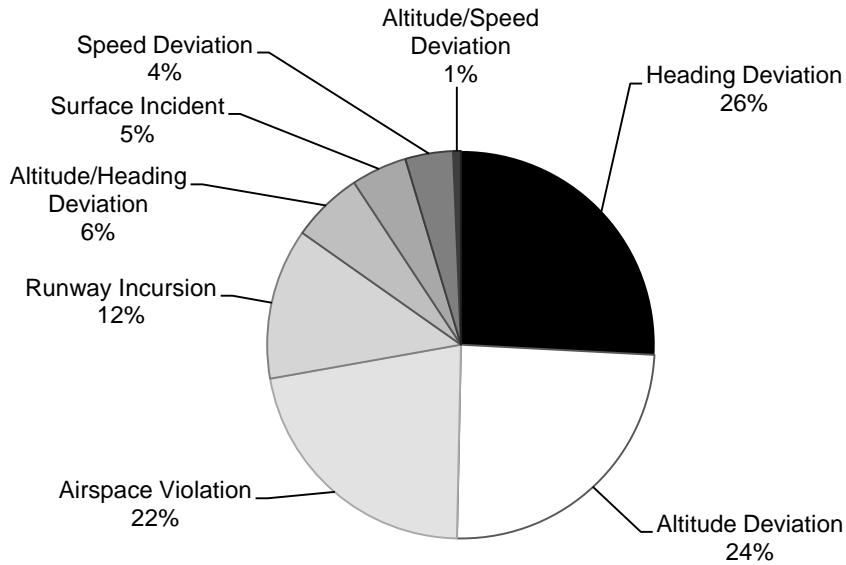
**Figure 11. Percent of Anomalies, Deviations and Airspace Violations.**

All anomalies, deviations and airspace violations that occurred in relation to a potential safety concern involving the use of an EFB or PED being used as an EFB were noted. Figure 11 depicts the results overall. Altitude, heading and speed deviations occur when a pilot fails to meet or maintain the altitude, heading or speed assigned to the aircraft by ATC. For example, if ATC assigns an aircraft to flight level (FL) 120, but the pilot mistakenly climbs to FL150. Runway incursions are a specific type of incident defined by the FAA as “any occurrence at an aerodrome involving the incorrect presence of an aircraft, vehicle or person on the protected area of a surface designated for the landing and take-off of aircraft” (FAA, 2011a). Surface incidents currently include any unauthorized activity on the movement area of the airport surface other than a surface intended for the take-off and landing of aircraft (e.g., taxiways)<sup>4</sup>. The type of anomaly that resulted from each event was tallied by type of operation, as presented in Table 9.

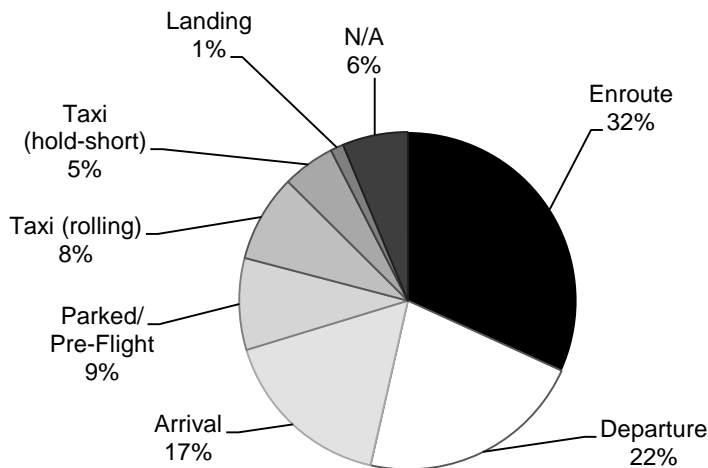
**Figure 12. Percent of Phase of Flight In Which Concerns Occurred.**

Pilots reported an EFB/PED concern that occurred in the enroute and departure phases of flight in 32% (76 reports) and 22% (52) of all ASRS reports, respectively. Concerns occurred in the arrival phase in 17% (40) of reports. Taxiing aircraft were involved in 13% (20 rolling and 12 holding short or involving a hold-short instruction), and only 9% (21) of reports involved aircraft that were parked during pre-flight. Three reports described EFB/PED concern during landing. Additionally, there were 15 reports in which the concern described was a general safety concern but not related to a specific event during the flight (refer to Table C-2 in [Appendix C](#) for the phase of flight for each type of operation by device type). Table 10 shows phase of flight by type of operation).

We examined the phase of flight in which the concern occurred. Pilots could note the phase of flight in two ways in the ASRS report: one was in the “phase of flight” field and the other was in the narrative. In some reports, the two did not match. That is, the EFB or PED concern was not consistent with the information in the ASRS phase of flight field, in some cases because the EFB concern did not occur at the same time as an anomalous event (e.g., altitude or heading deviation). To provide consistency in examining the phase of flight, we used the following seven categories: parked/pre-flight, taxi (rolling), taxi (hold short), departure, enroute, landing, and arrival. The results are presented in Figure 12.
